# Kennebunk Historic Preservation Overlay District Design Guidelines

The Historic Preservation Commission  
Town of Kennebunk, Maine

Turk Tracey & Larry Architects, LLC  
Portland, Maine

2002

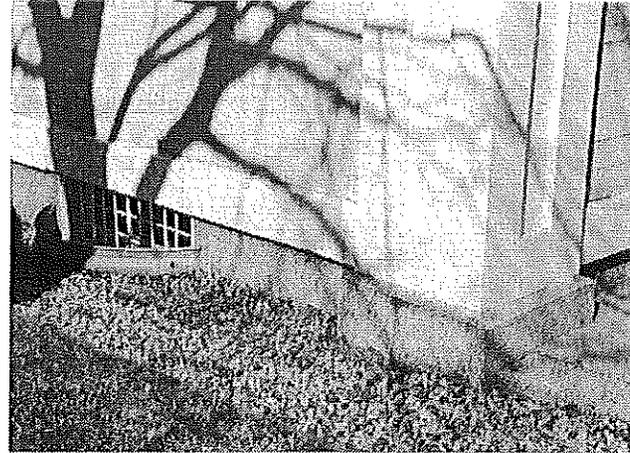
Decorative corner block and window well

Granite foundations are of slab or block construction, with interior pier walls, and occasionally incorporate decorative corner blocks and water tables. Water tables, or water table boards, are decorative features that divert rainwater away from the surface of a building, and most in the District are constructed of wood. Raised foundations often incorporate basement windows, wells, or grilles to allow light into the basement or crawlspace, and to provide ventilation.

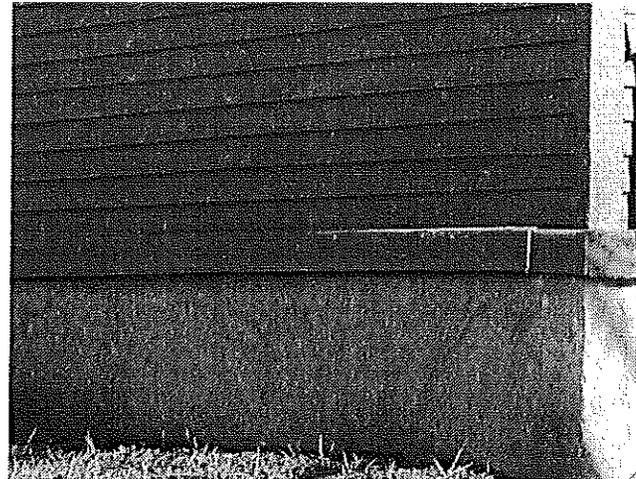
Granite foundation and water table

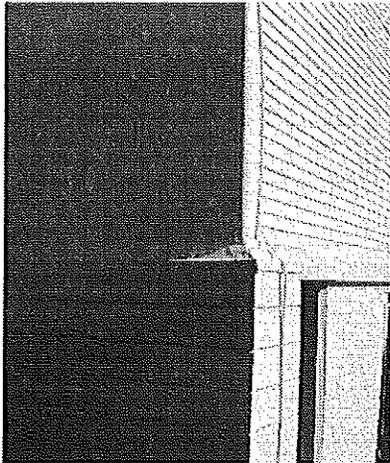
Wood flush board siding and clapboards

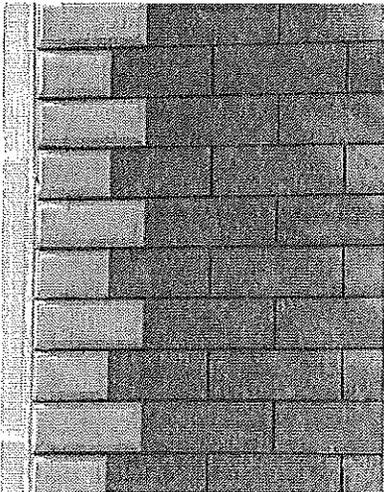
Wood siding scored to resemble stone

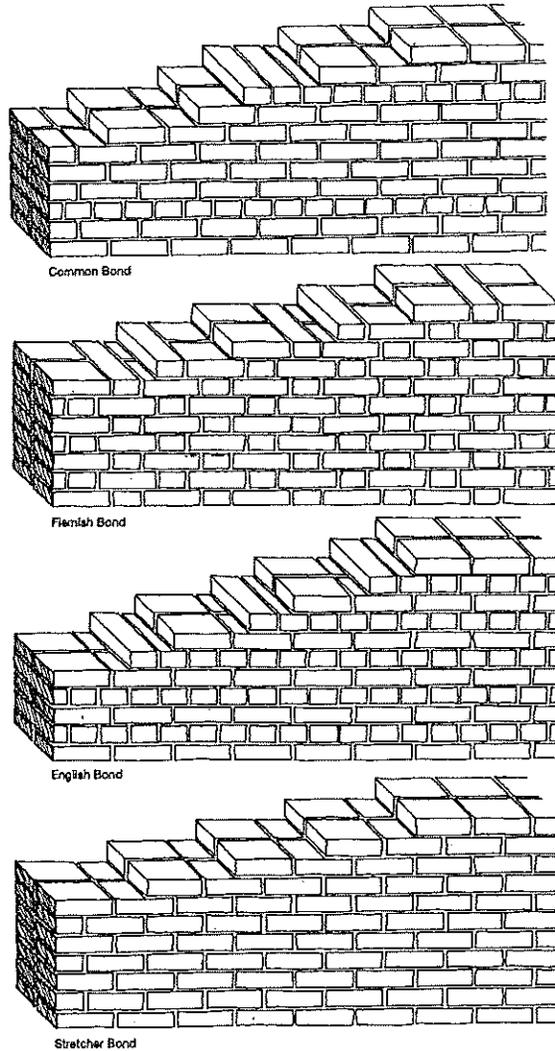
Common brick bonds (Source unknown).

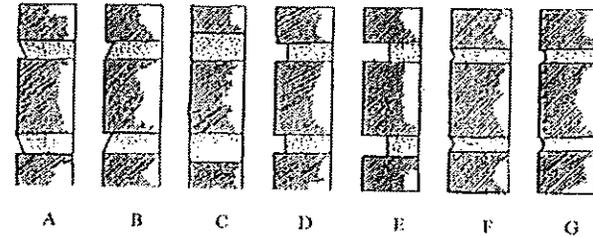
Typical mortar joints. A. Struck; B: Weathered; C: Flush; D: Raked; E: Stripped; F: V; G: Concave. Adapted from *Practical Bricklaying: A Handbook of Instruction and Manual for the Journeyman* by Howard L. Briggs, 1924.

- If bricks must be replaced, replacement bricks should match the original as closely as possible in terms of color, size and texture. Care should also be taken to match the size, tooling, and color of the mortar joints. New brickwork should be laid in the same bond and should replicate the same joint width and pointing technique.

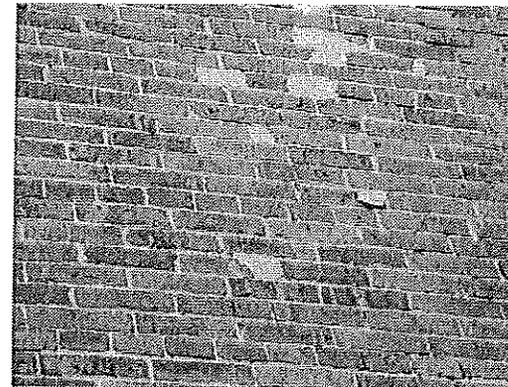
Inappropriate repointing and brick matching

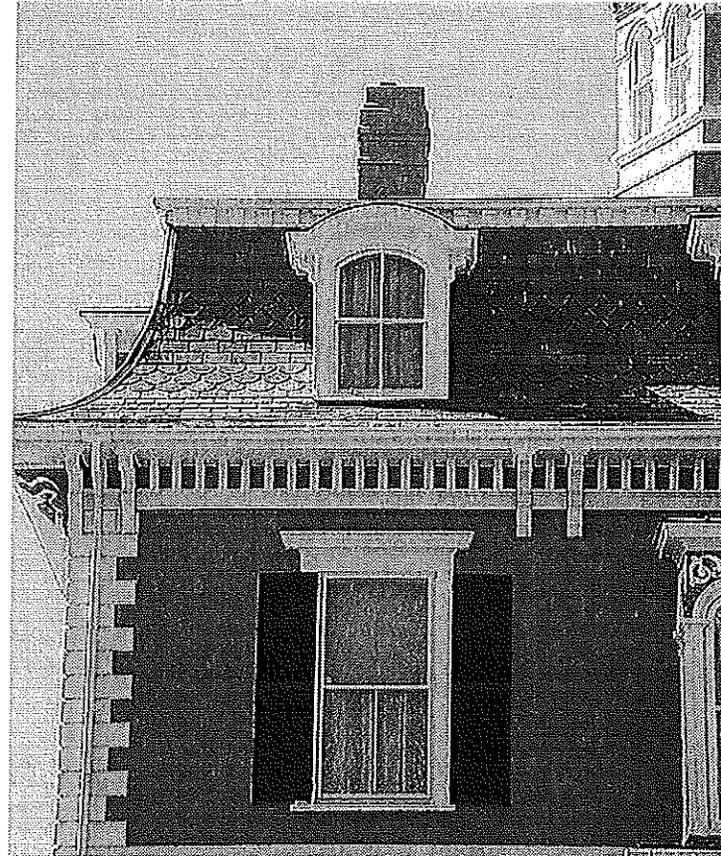
Decorative or "patterned" slate

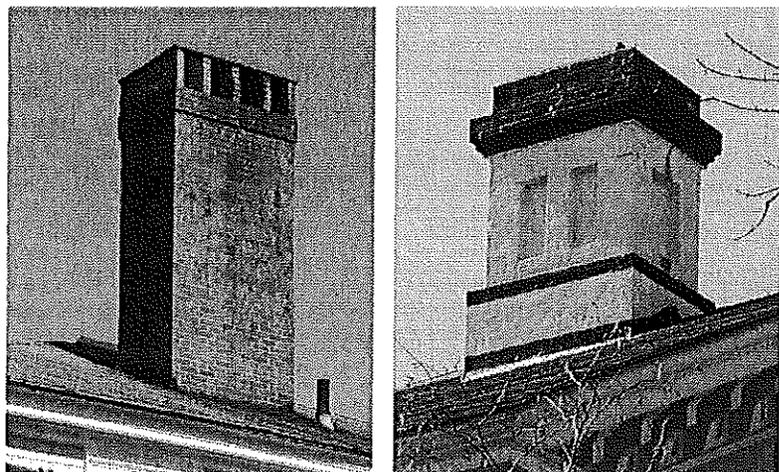
Typical chimney construction in the district showing simple construction and painted stack.

Most buildings in the District have one or more chimneys. Early structures have simple, unarticulated chimneys. As the nineteenth century progressed and architectural styles changed chimneys became more articulated. A few buildings have painted chimneys, usually painted white with a band of black encircling the top. Chimneys should be checked annually for spalling brick and loose mortar, and repointed as necessary.

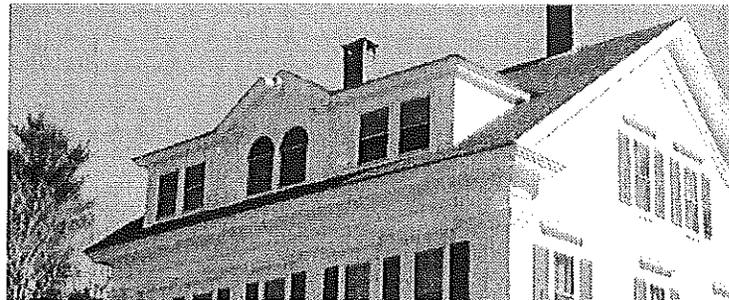
Wall dormer

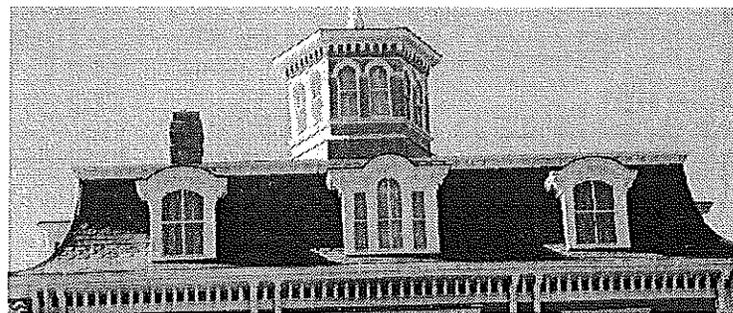
Arched top dormer

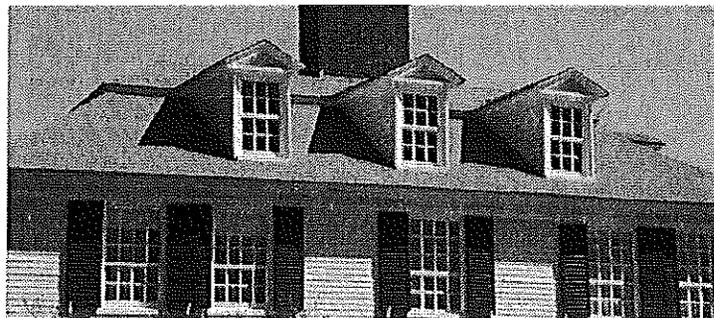
Gabled roof dormer

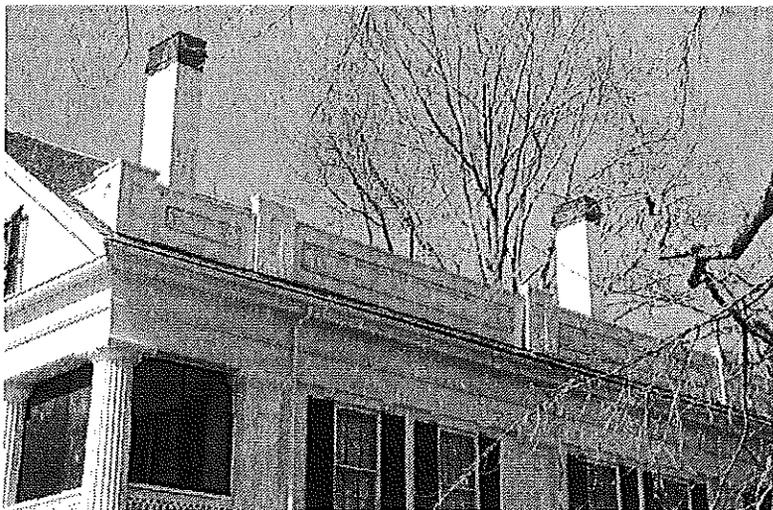
Roof top balustrade

Balustrades are one of the most noticeable character defining features of a structure, and several buildings in the District originally had roof and/or porch balustrades. Balustrades are susceptible to deterioration from weathering and only a few remain today. Every effort should be made to retain balustrades, and they should be repaired as needed. If replacement is necessary the materials should be in-kind, matching the details and finish of the original as closely as possible.

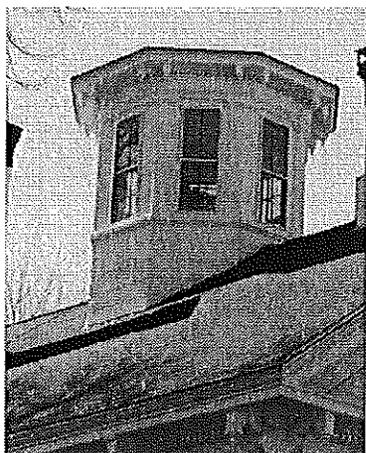
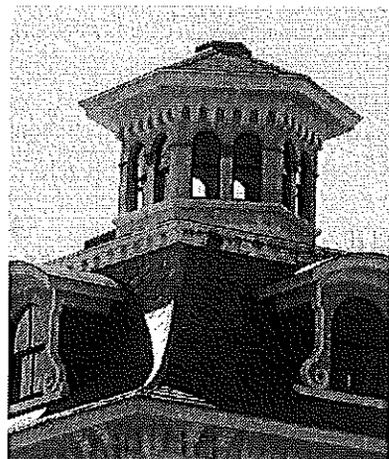
Character defining cupolas

Cupolas are small, decorative, windowed structures astride the ridge of a roof, and can be used to exhaust hot air from the house. Three houses on Summer Street have large cupolas centered on the roof, and several barns have smaller ones. Every effort should be made to retain historic cupolas, including maintenance of roofing materials, flashing, windows and decorative trim.

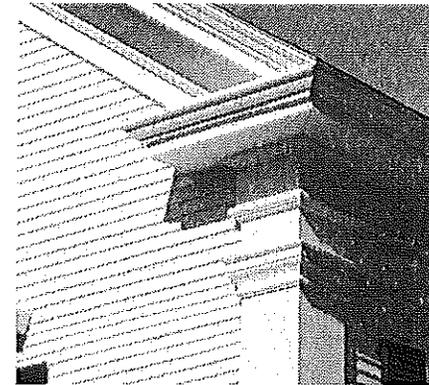
Cornice return on Greek Revival building

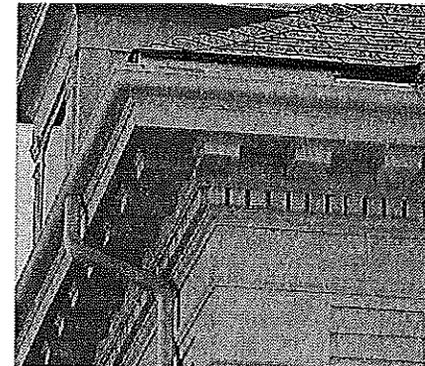
Dentil course

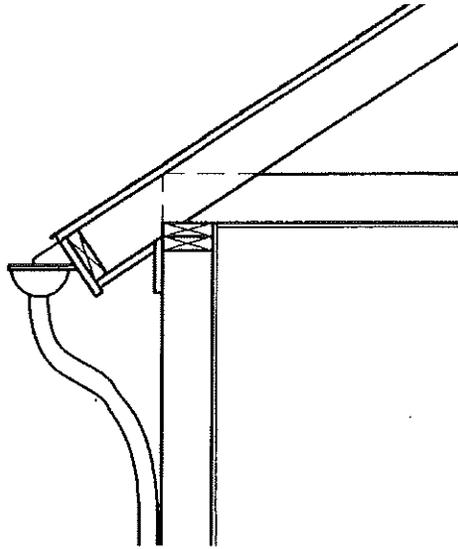
Half-round gutter

There are two types of roof drainage systems in the District, both designed to collect water along the roof edge and channel it away from the building. The most common system is an exterior drainage system, which includes gutters and downspouts, made of wood or metal, and flashing. Gutters are installed along the cornice level of pitched-roof buildings to conduct water to the downspouts. Metal gutters come in a variety of shapes within the District, including half-round or formed ogee, and typically are made of galvanized metal, copper, lead-coated copper or aluminum. Half-round gutters with round downspouts are a common style on many buildings. A few houses retain their original built-in drainage systems, in which lined gutters are built into the cornice, making the system less visible than external gutter systems. The elements of historic drainage systems contribute to the character of the building, and careful consideration should be given to choosing the same or similar materials when undertaking any repair to the drainage system.

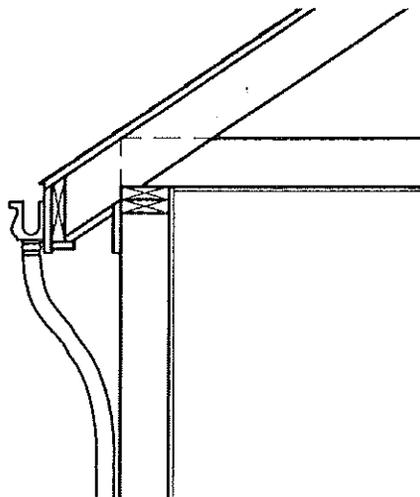
Ogee gutter

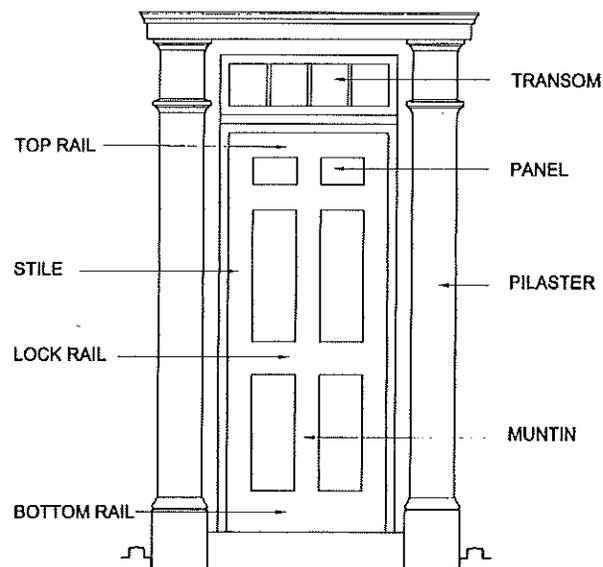
Illustration identifying parts of door. Six-panel door with four-light transom shown.

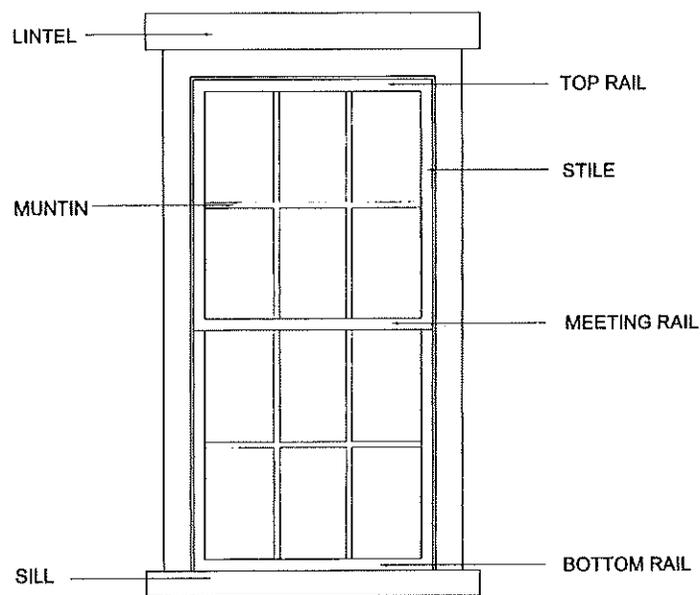
Illustration identifying parts of window. 6/6 double-hung sash shown.

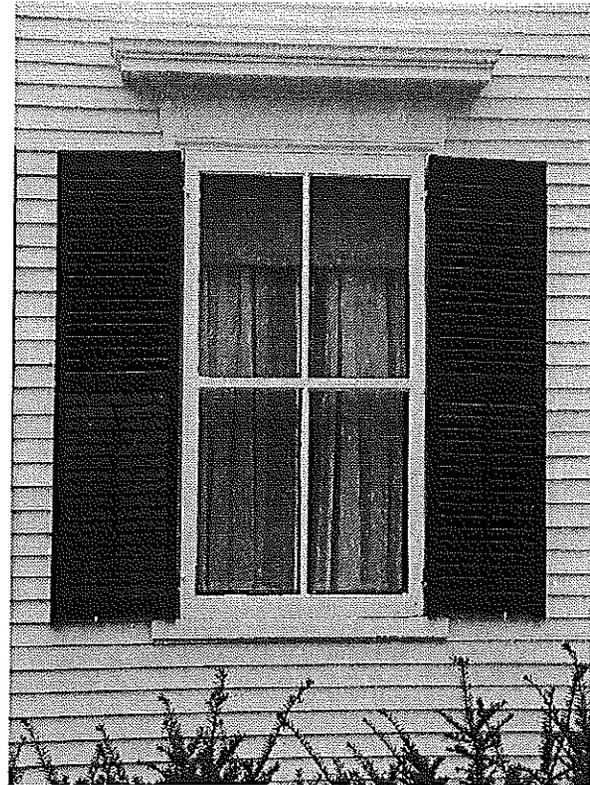
Well proportioned 2/2 light storm window over a 2/2 double-hung sash. In addition, the shutters are appropriately sized and placed.

- Storm windows that detract from the original design of the window are not recommended. Storm windows should be selected with frames that are similar in width and finish to the original window unit, and should fit tightly.
- Storm sash should be set as far back from the plane of the exterior wall surface as practicable.
- Meeting rails should align with the primary sash.
- Color of the exterior frames should match the exterior window frames, and the glass should be clear.

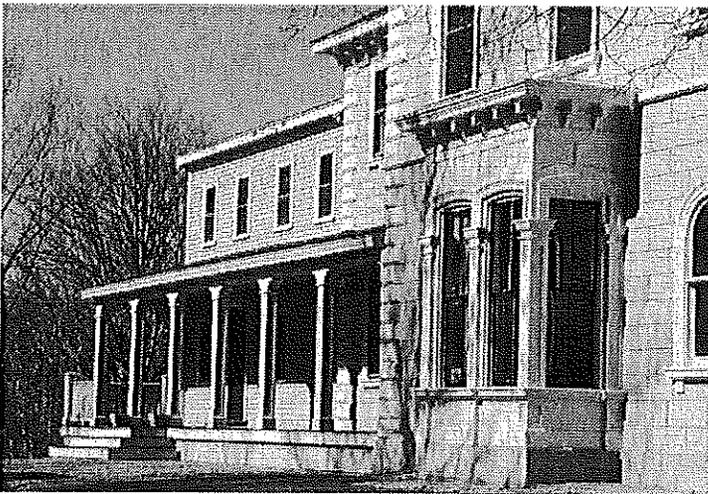
Porch replicated using archival information

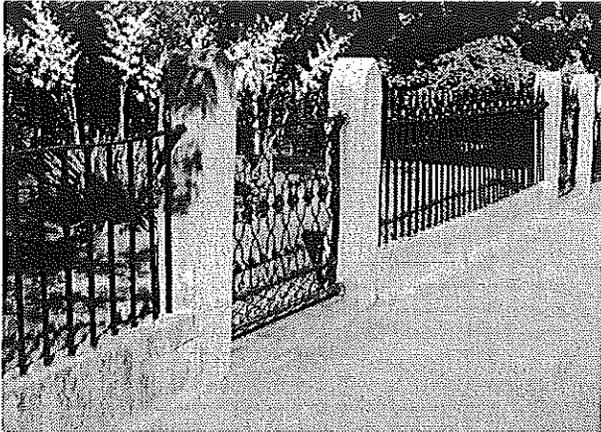
Summer Street iron and granite fence

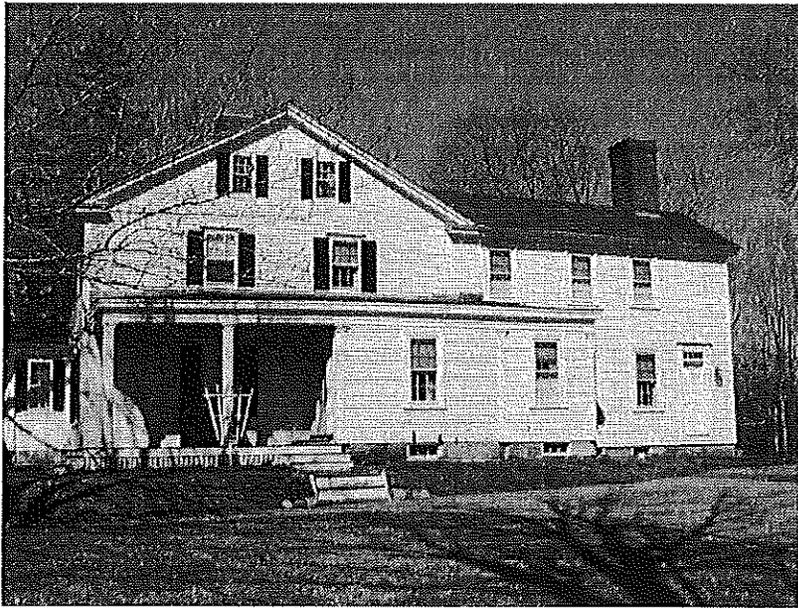
Sympathetic two-story addition at rear

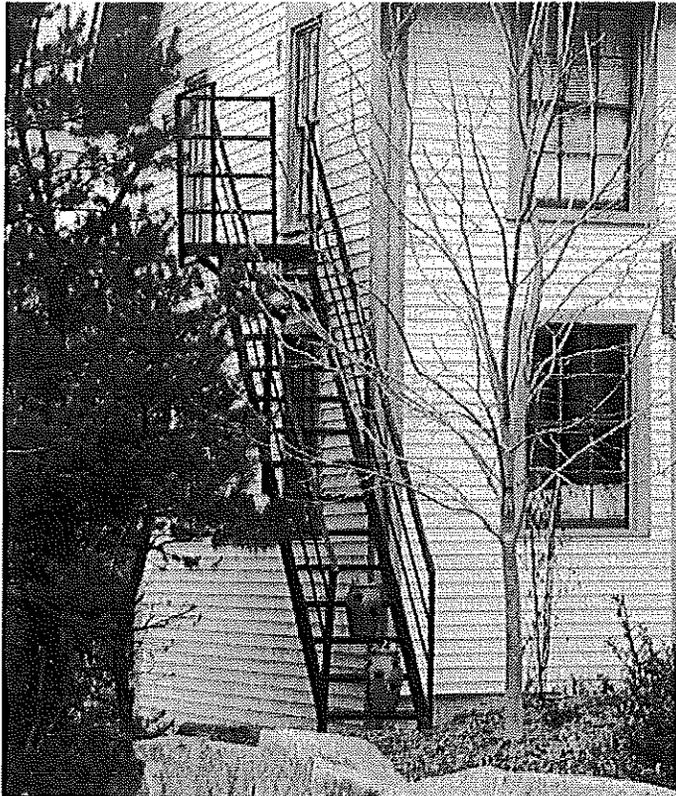
Nice example of a sympathetic fire escape

historic structures are constructed of iron or aluminum, painted black. Metals provide greater strength than wood, and open treads prevent snow and ice buildup.
