Porches

Siding

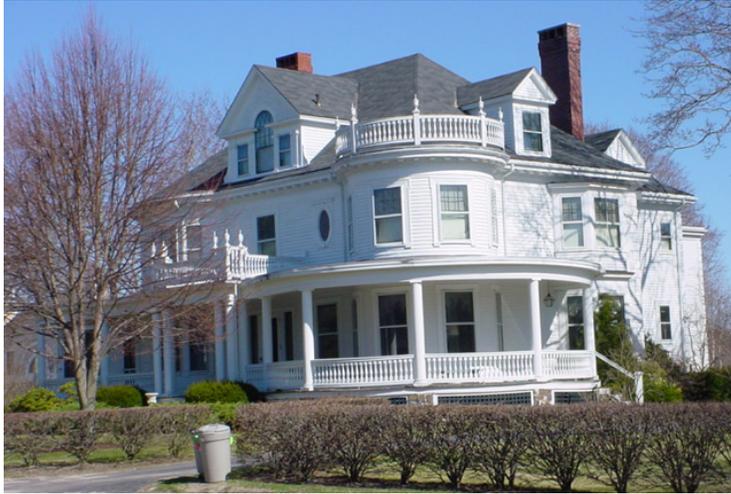
Queen Anne wrap-around porch

The porch is an important architectural element, not only as a protected entry to a house but as a feature of the larger streetscape as well. Porches became popular during the mid nineteenth century, and porches are common on Italianate, Second Empire, and Queen Anne Style houses. The individual porch components, such as the columns, pediment, and railings, have all been selected to enhance and reinforce the architectural style of the building. Some porches have plain posts and minimal ornamentation, and others are designed with complex shapes, elaborate columns, and cornice details. Porches need regular preventive and corrective maintenance because of exposure to the elements, use, and proximity to the ground. Porch elements are some of the most frequently replaced elements of the house. The removal of a porch or any of the individual features detracts both from the character of the house and the neighborhood.

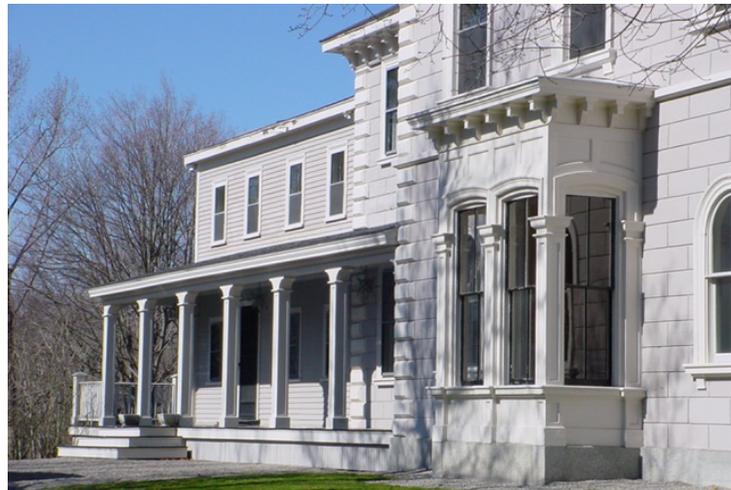
Porch replicated using archival information

Porches have been removed from several houses in the District. Property owners desiring to restore a missing porch, when documentary evidence exists, are encouraged to do so using vintage photographs or drawings.

- If a porch is to be reconstructed where one was removed in the past, physical evidence or photographic documentation should be used as a guide. If a porch is to be rebuilt or expanded, the new construction should match the design and materials of the original.

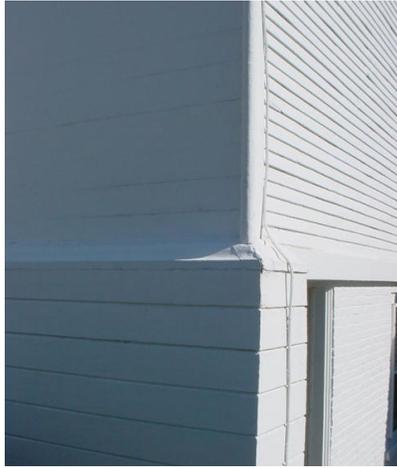
Wood flush board siding and clapboards

The exterior wall treatment of a building is a principal character-defining feature of the structure. Siding protects the house from the damaging effects of weather, and requires regular maintenance. Many of the structures in the District retain their original siding, and there is considerable diversity in design and appearance. Traditional wood clapboards are the prevalent siding material, although flush boards, board-and-batten, and boards scored to resemble stone were used with specific architectural styles. In addition, wood shingles in various shapes and sizes are found on several buildings.

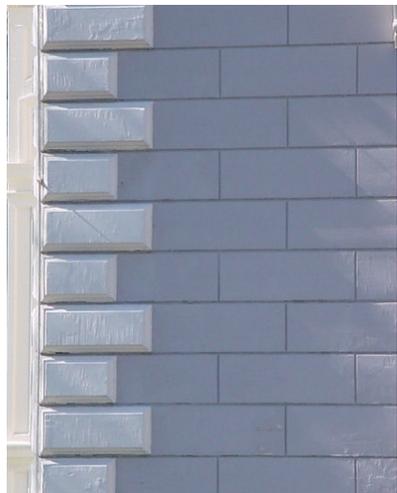
Wood siding scored to resemble stone
